STOPBANK PERFORMANCE DURING THE  
2010 – 2011 CANTERBURY EARTHQUAKE SEQUENCE

A thesis submitted in partial fulfilment of the requirements for the Degree  
of Master of Science in Engineering Geology

Sophie Elizabeth Bainbridge

2013

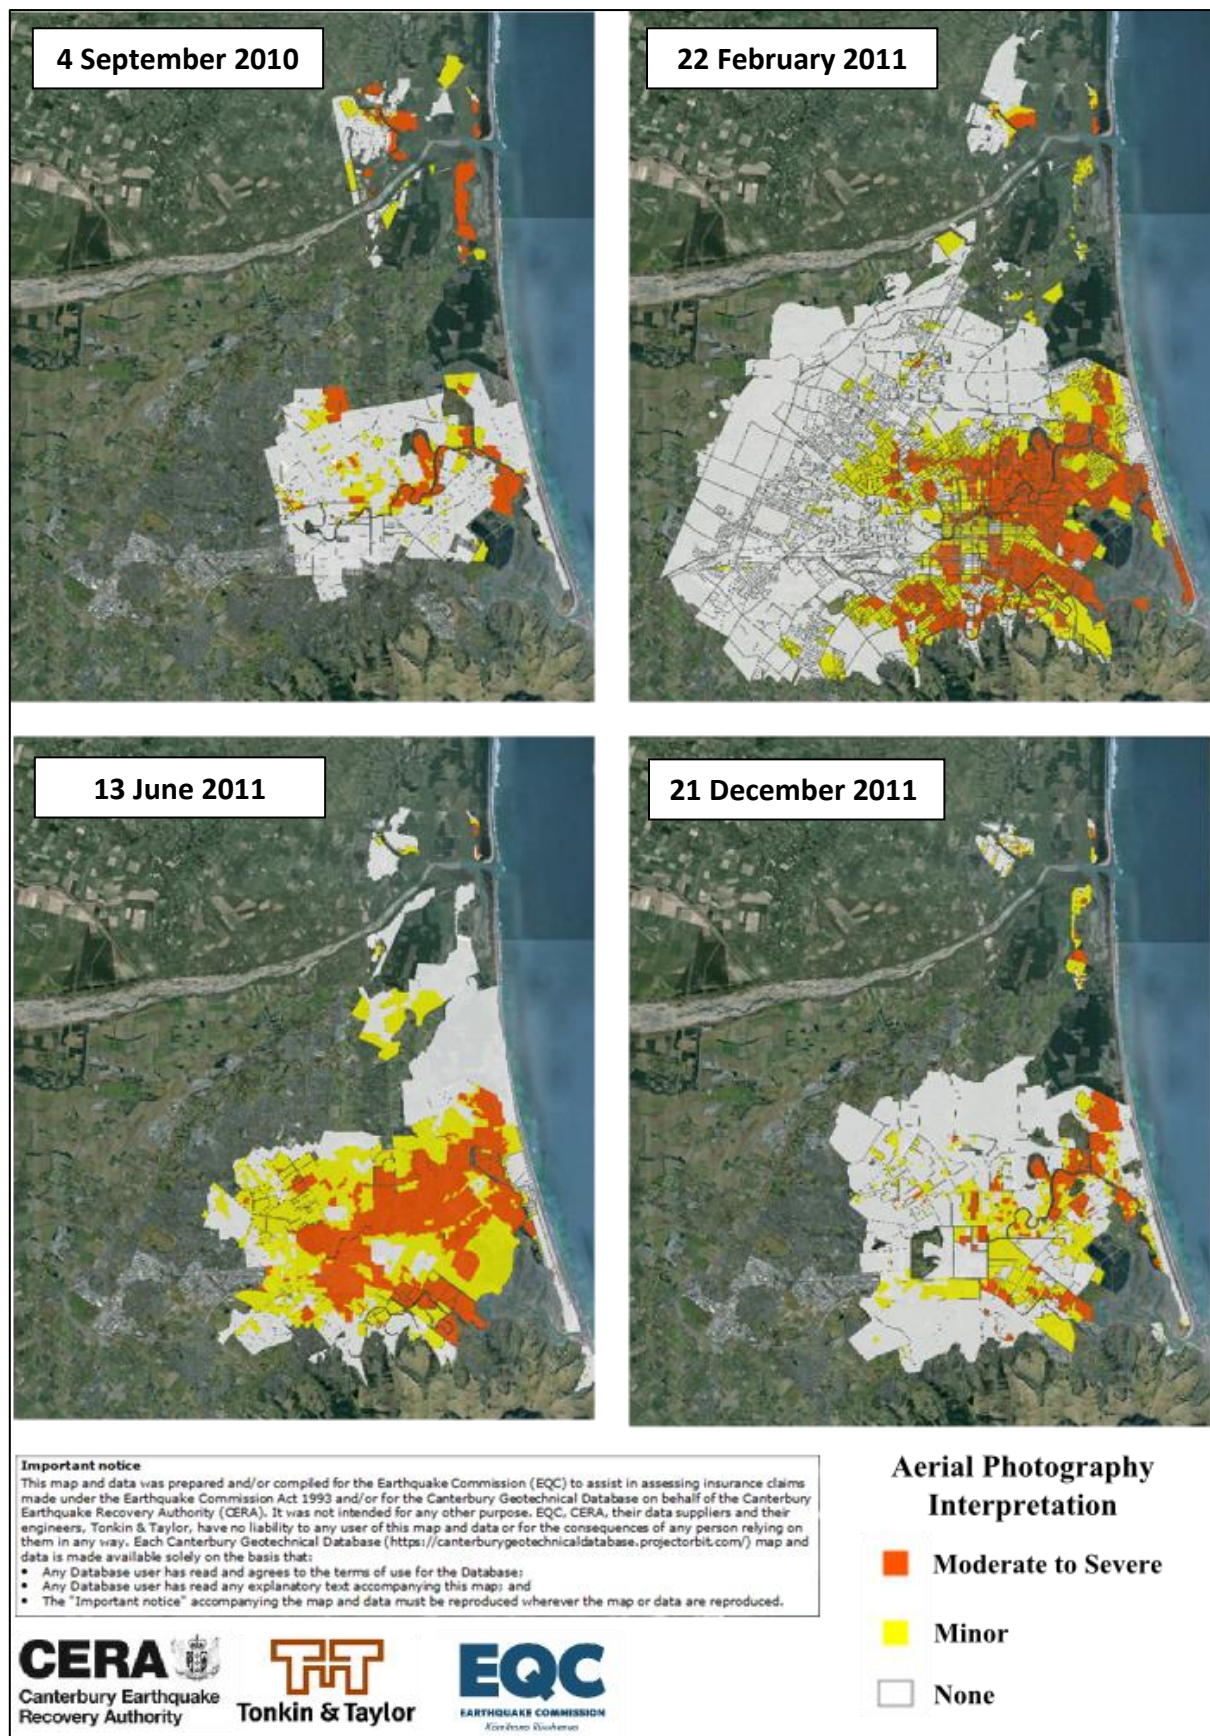
Immediately following the two earthquakes, reconnaissance work was performed to investigate the extent and features of the damage. Figure 10 shows the distribution of liquefaction observed in the suburbs east of the CBD following the September 2010 and February 2011 earthquakes, respectively. These maps, which were constructed from visual identification of liquefaction using aerial photographs of varying quality and light conditions taken after each significant event, shows the extent of ejected material across the city. Liquefaction was categorised into the following classifications:

FIGURE 10: OBSERVED LIQUEFACTION INTERPRETED FROM AERIAL PHOTOGRAPHY. CGD0200 - 11 FEB 2013.

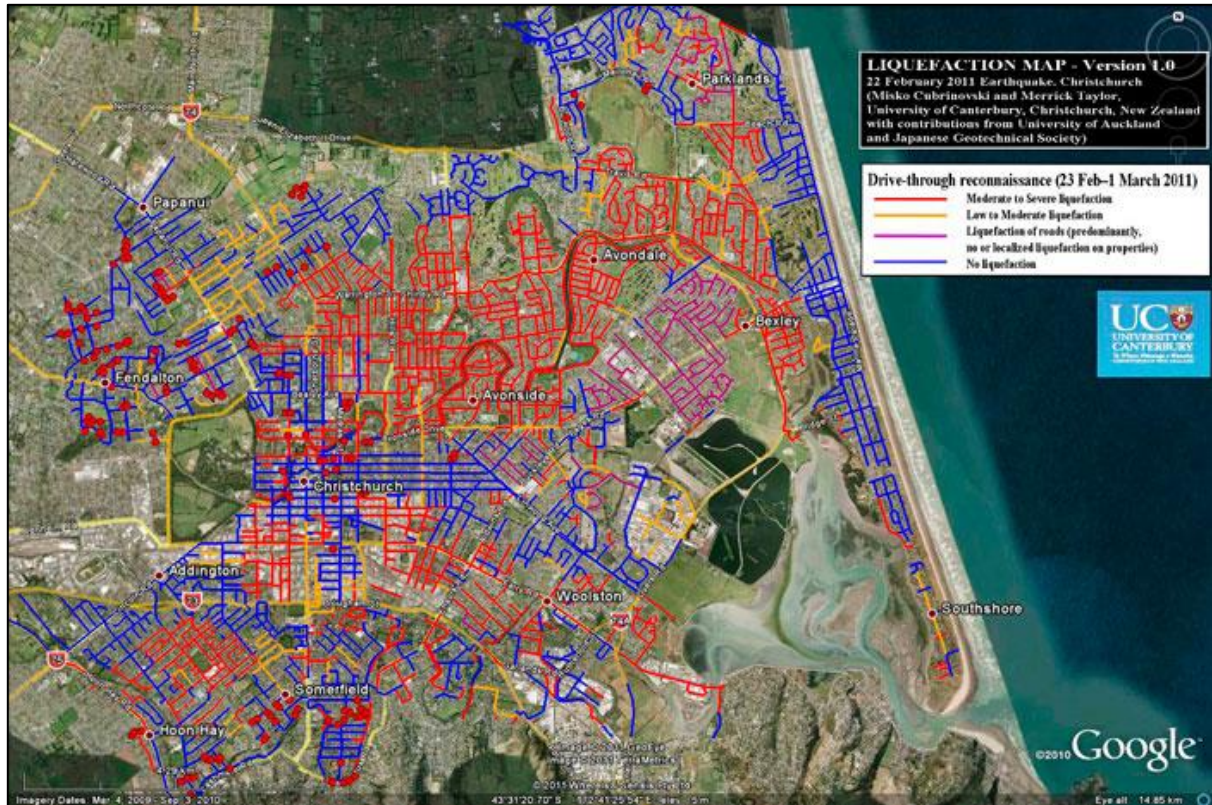
Higher resolution mapping was also undertaken following the earthquakes by personnel on foot and by car. Whilst these maps are of higher resolution they do not cover such extensive areas as the maps derived from aerial photographs. An example of one of the maps following the 22 February 2011 earthquake is shown in Figure 11.

FIGURE 11: HIGH-RESOLUTION LIQUEFACTION MAP (CUBRINOSKVI & TAYLOR, 2011)

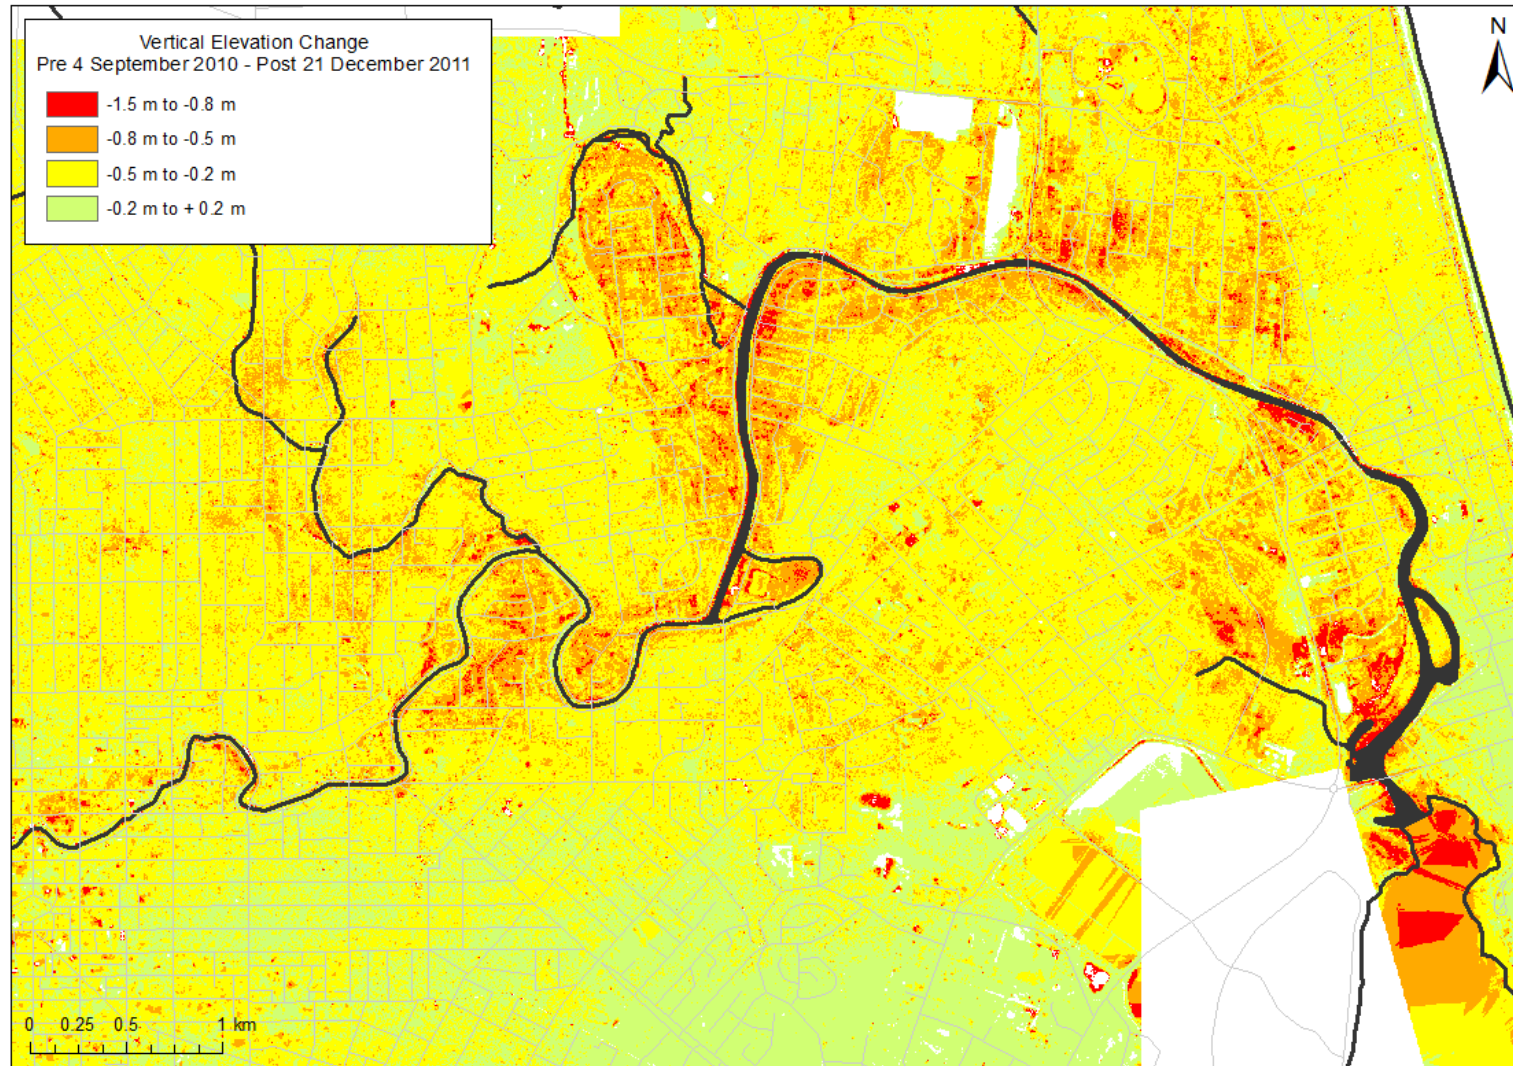
The extensive liquefaction and lateral spread also resulted in permanent vertical (and horizontal) ground movements. Figure 12 and Figure 13 show the vertical elevation changes over the entire Canterbury Earthquake Sequence, in lower Avon and Kaiapoi, respectively. A series of Digital Elevation Models (DEMs) were created following the earthquakes that summarize vertical elevation changes and horizontal ground movements (CGD0500). Vertical elevation changes were calculated from LiDAR acquired prior to the earthquakes and following each of the significant earthquake and are illustrated as colour banded DEMs. The horizontal ground movements for each earthquake were calculated using set points on infrastructure or on the ground to quantify the approximate horizontal movement of a particular point. The primary limitations of these data sets are the margin of accuracy accompanying each map. This was not provided post-survey, however statistics for calibration of the initial LiDAR point cloud sets are summarised in Table 1. It should be note that once DEMs are compared for relevant earthquakes, this error will increase.

FIGURE 12: VERTICAL ELEVATION CHANGE CANTERBURY EARTHQUAKE SEQUENCE - AVON RIVER

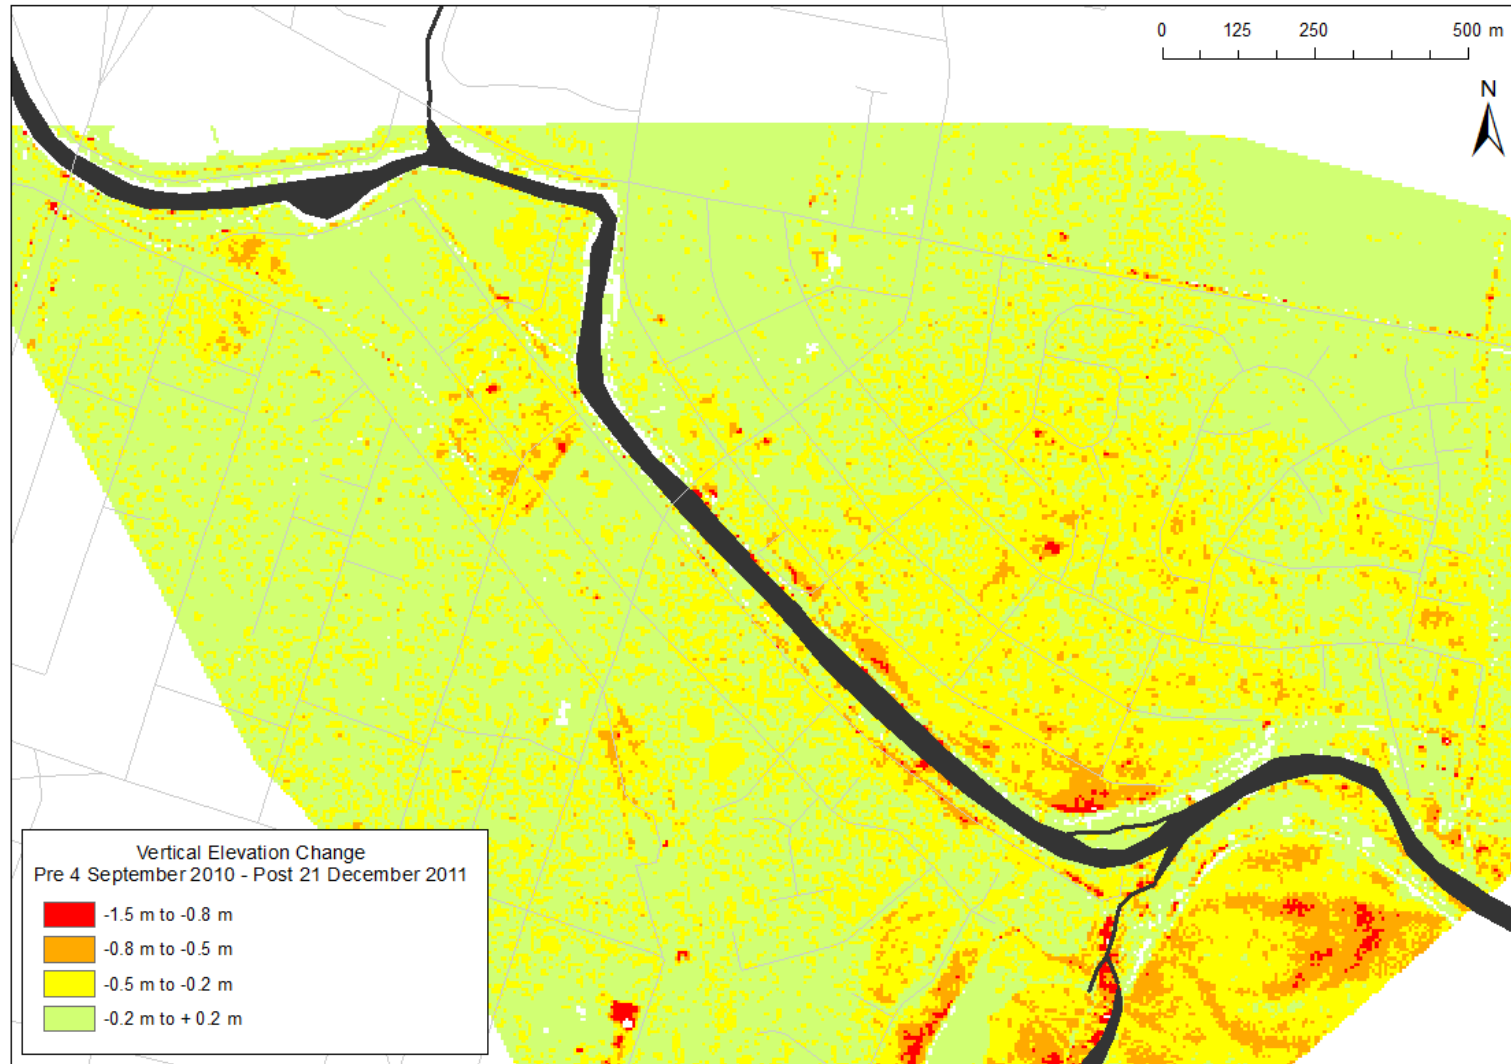
FIGURE 13: VERTICAL ELEVATION CHANGE CANTERBURY EARTHQUAKE SEQUENCE - KAIAPOI RIVER

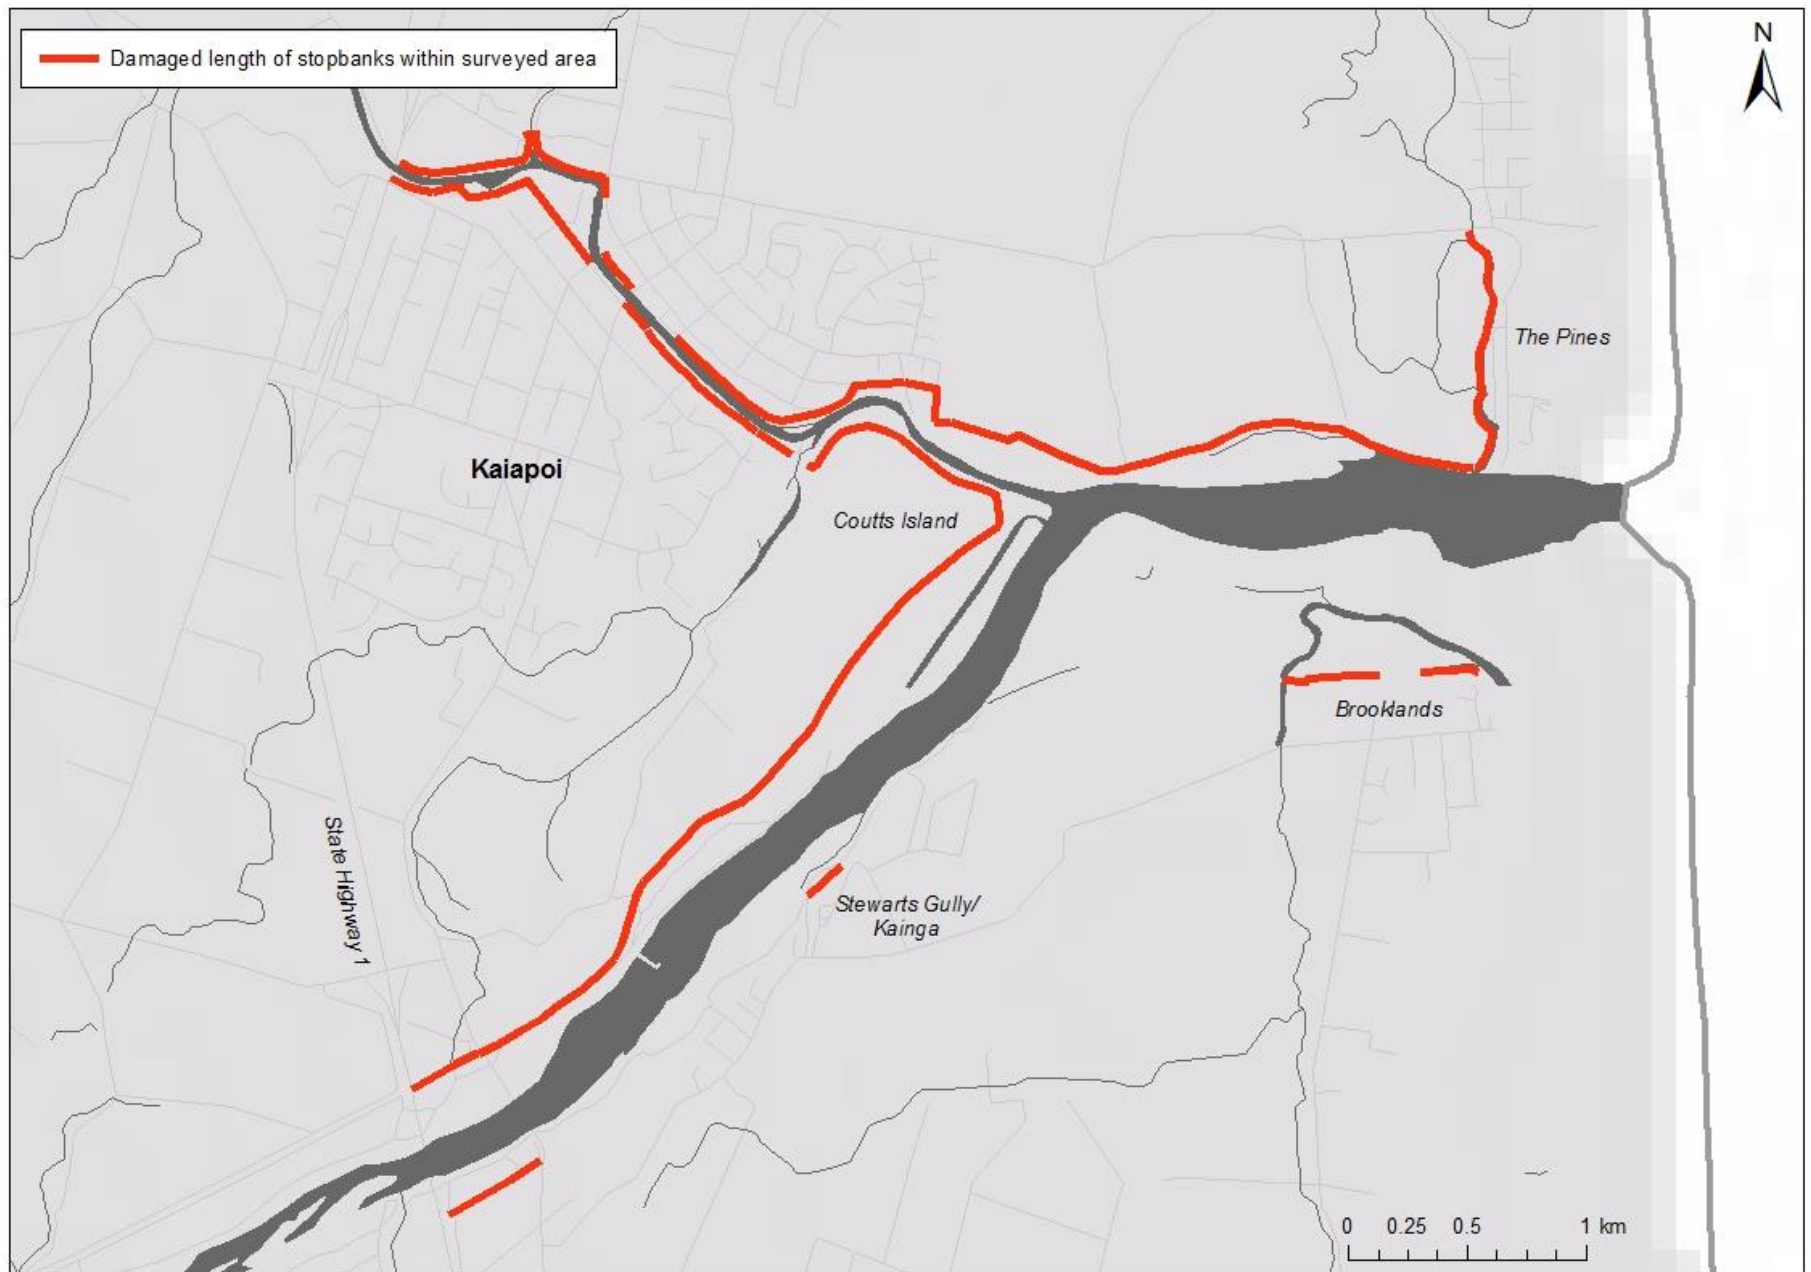
The total damage length for all three rivers (including damage to stopbanks and damage to river banks) resulting from the cumulative effect of all four significant earthquakes was approximately 38 km, with a total of 28 km of damage to the stopbank system, with the total lengths of damage for each of the rivers are summarised in Table 5 and illustrated in Figure 17 and Figure 18.

FIGURE 17: DAMAGED LENGTHS OF STOPBANK WITHIN WEC SURVEYED AREA

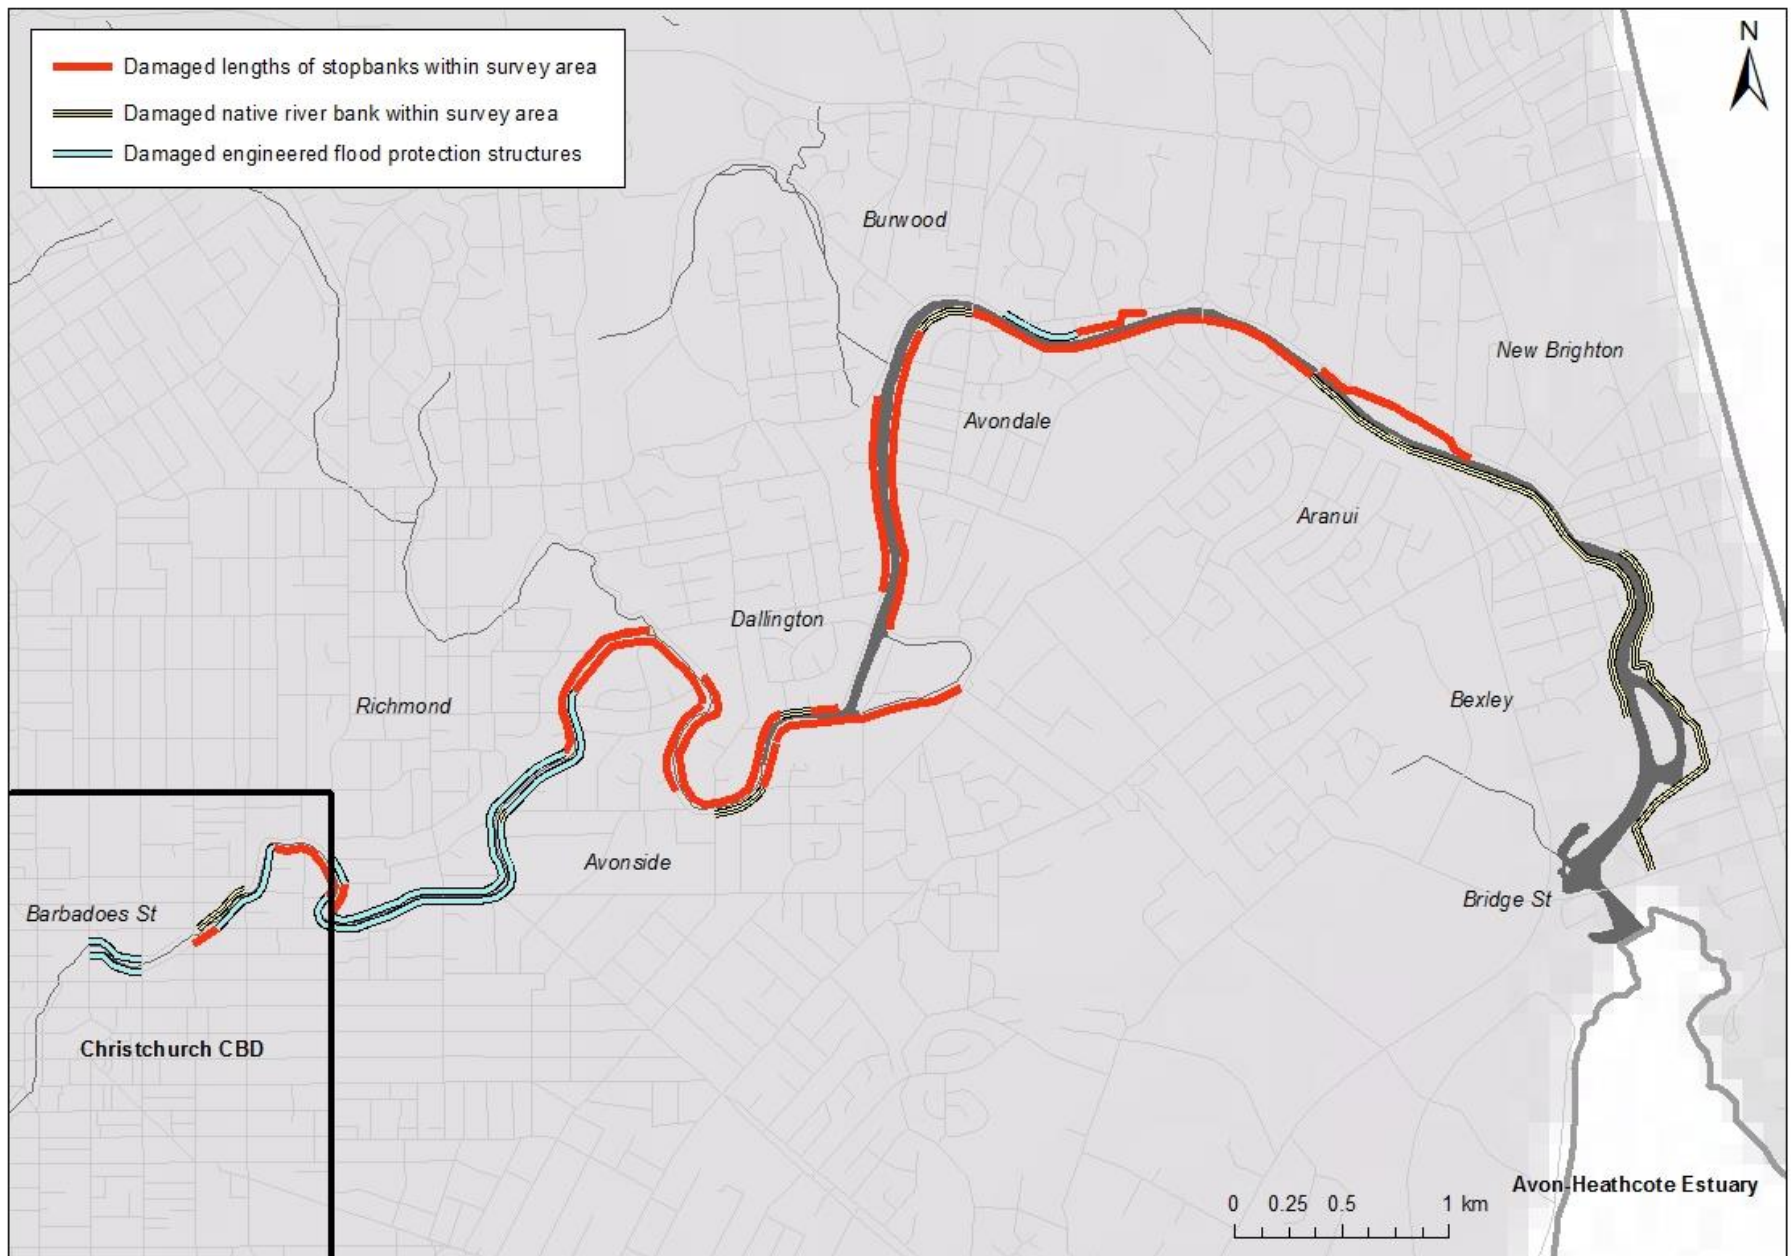
FIGURE 18: DAMAGED LENGTHS OF STOPBANK WITH AVON SURVEYED AREA

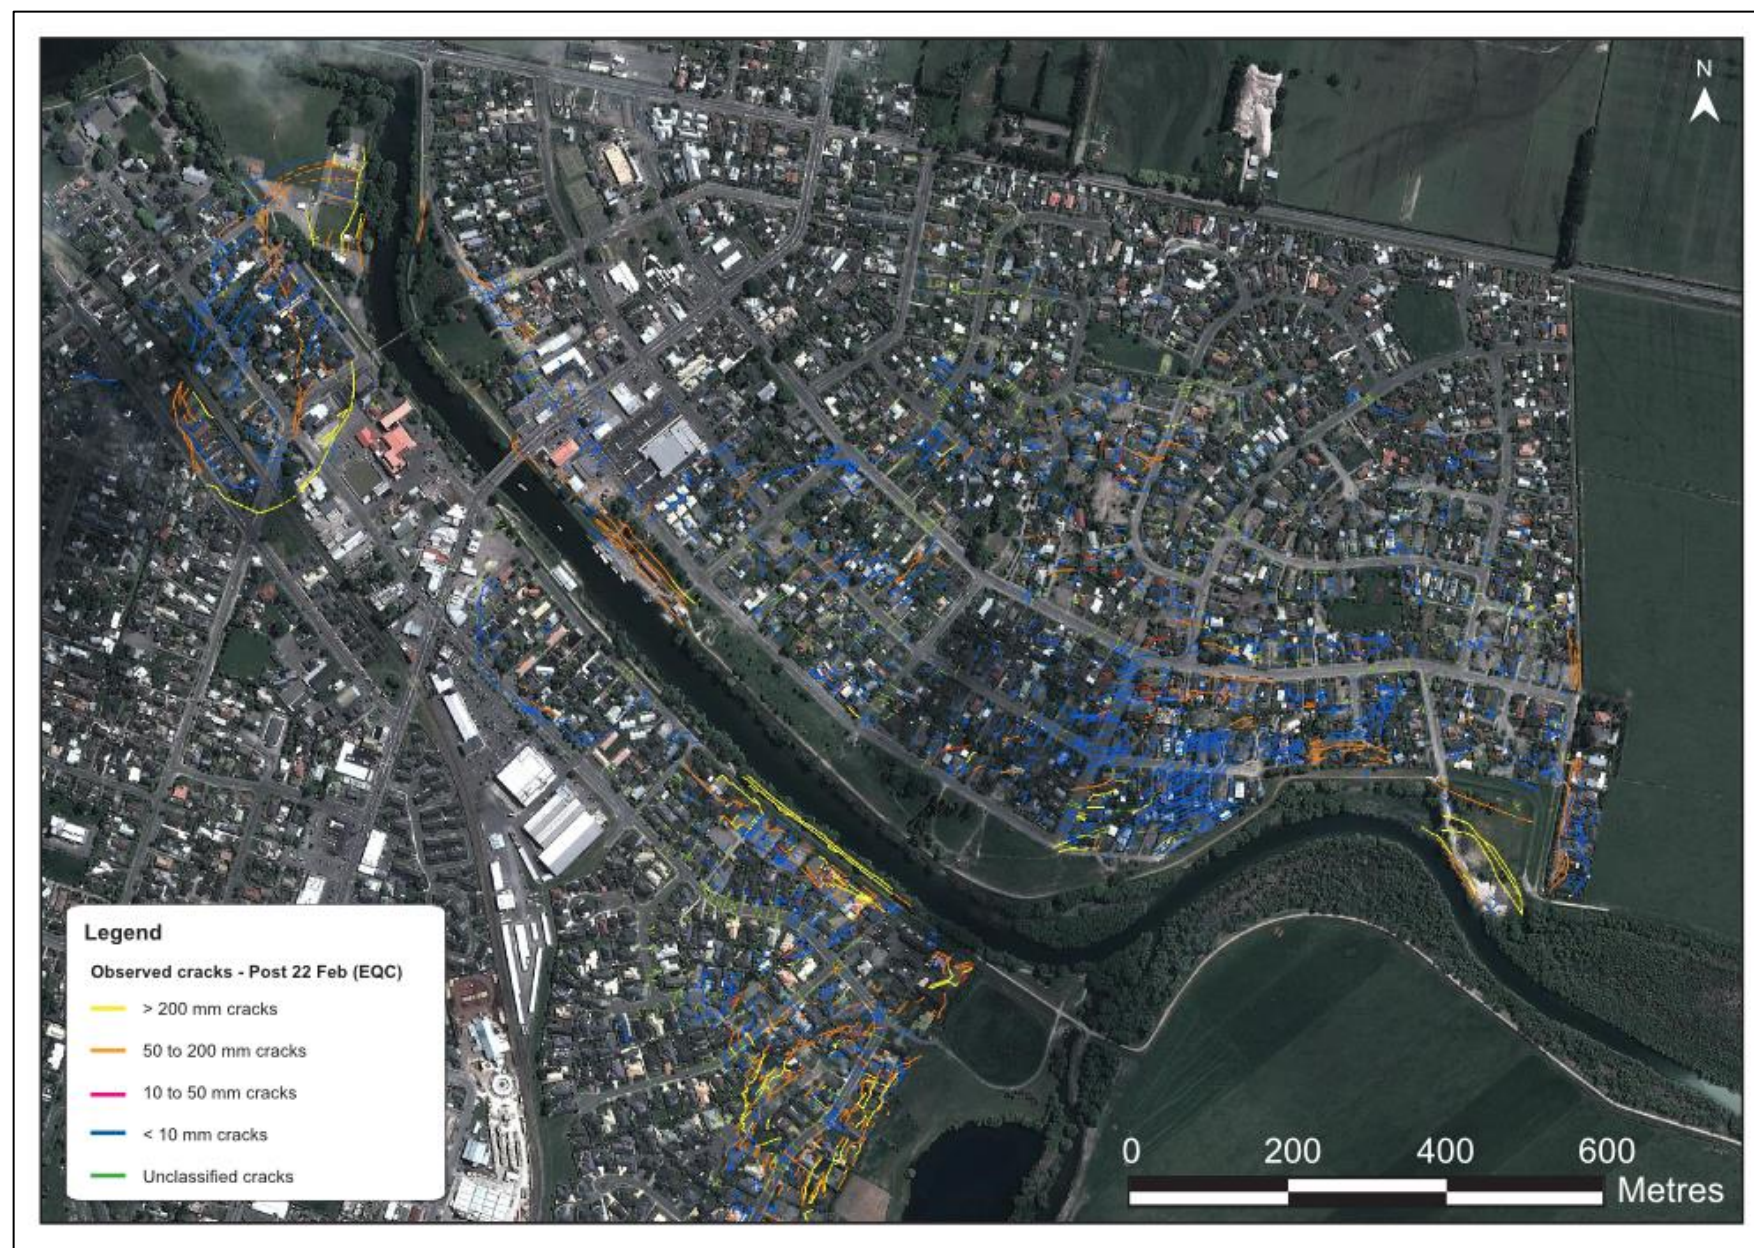
According to CGD0400 ground cracks were apparent along approximately half of the surveyed length of the Kaiapoi River. Multiple ground cracks greater than 200 mm in width were identified east of Raven Quay, at the end of Hall Street and adjacent to Revell Street. The first of these two locations correlate with significant stopbank damage.

FIGURE 28: KAIAPOI RIVER OBSERVED CRACKS - POST 22 FEBRUARY 2011 (CGD0400).

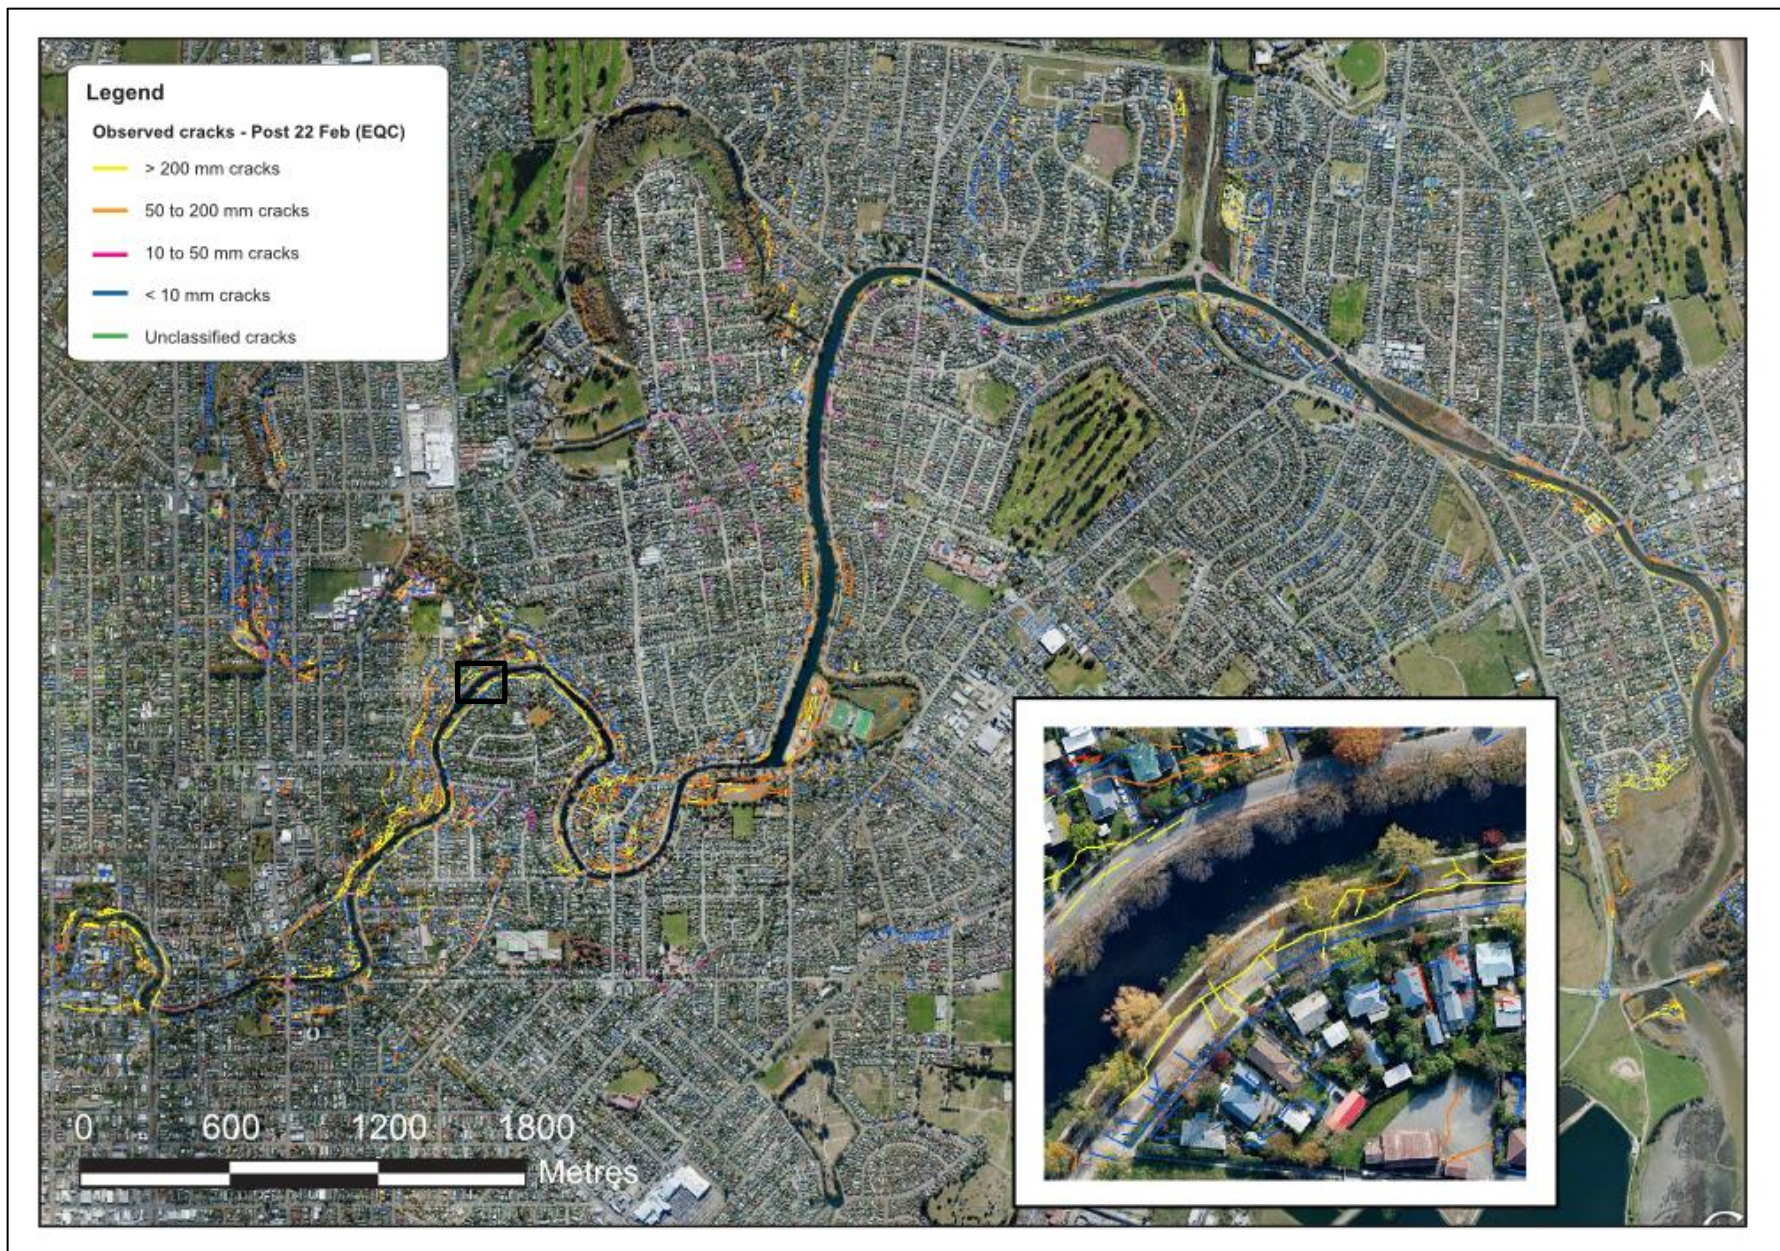
There are cracks adjacent to the river along the majority of the Avon River with the cracks generally being the widest, greater than 200 mm, adjacent to the meandering loops and towards the mouth of the estuary. Cracks along the rest of the river are in the range of 10 to 200 mm wide. Generally, the density of the cracks decreases with distance from the river, with significant cracking still occurring as far back as 150 m from the river. Cracks typically track in a parallel direction to the river, however at sharp bends in the river there are often multiple transverse cracks fanning out, as illustrated on the Dallington Loop in Figure 29.

FIGURE 29: AVON RIVER OBSERVED CRACKS, POST 22 FEBRUARY 2011 (CGD0400).

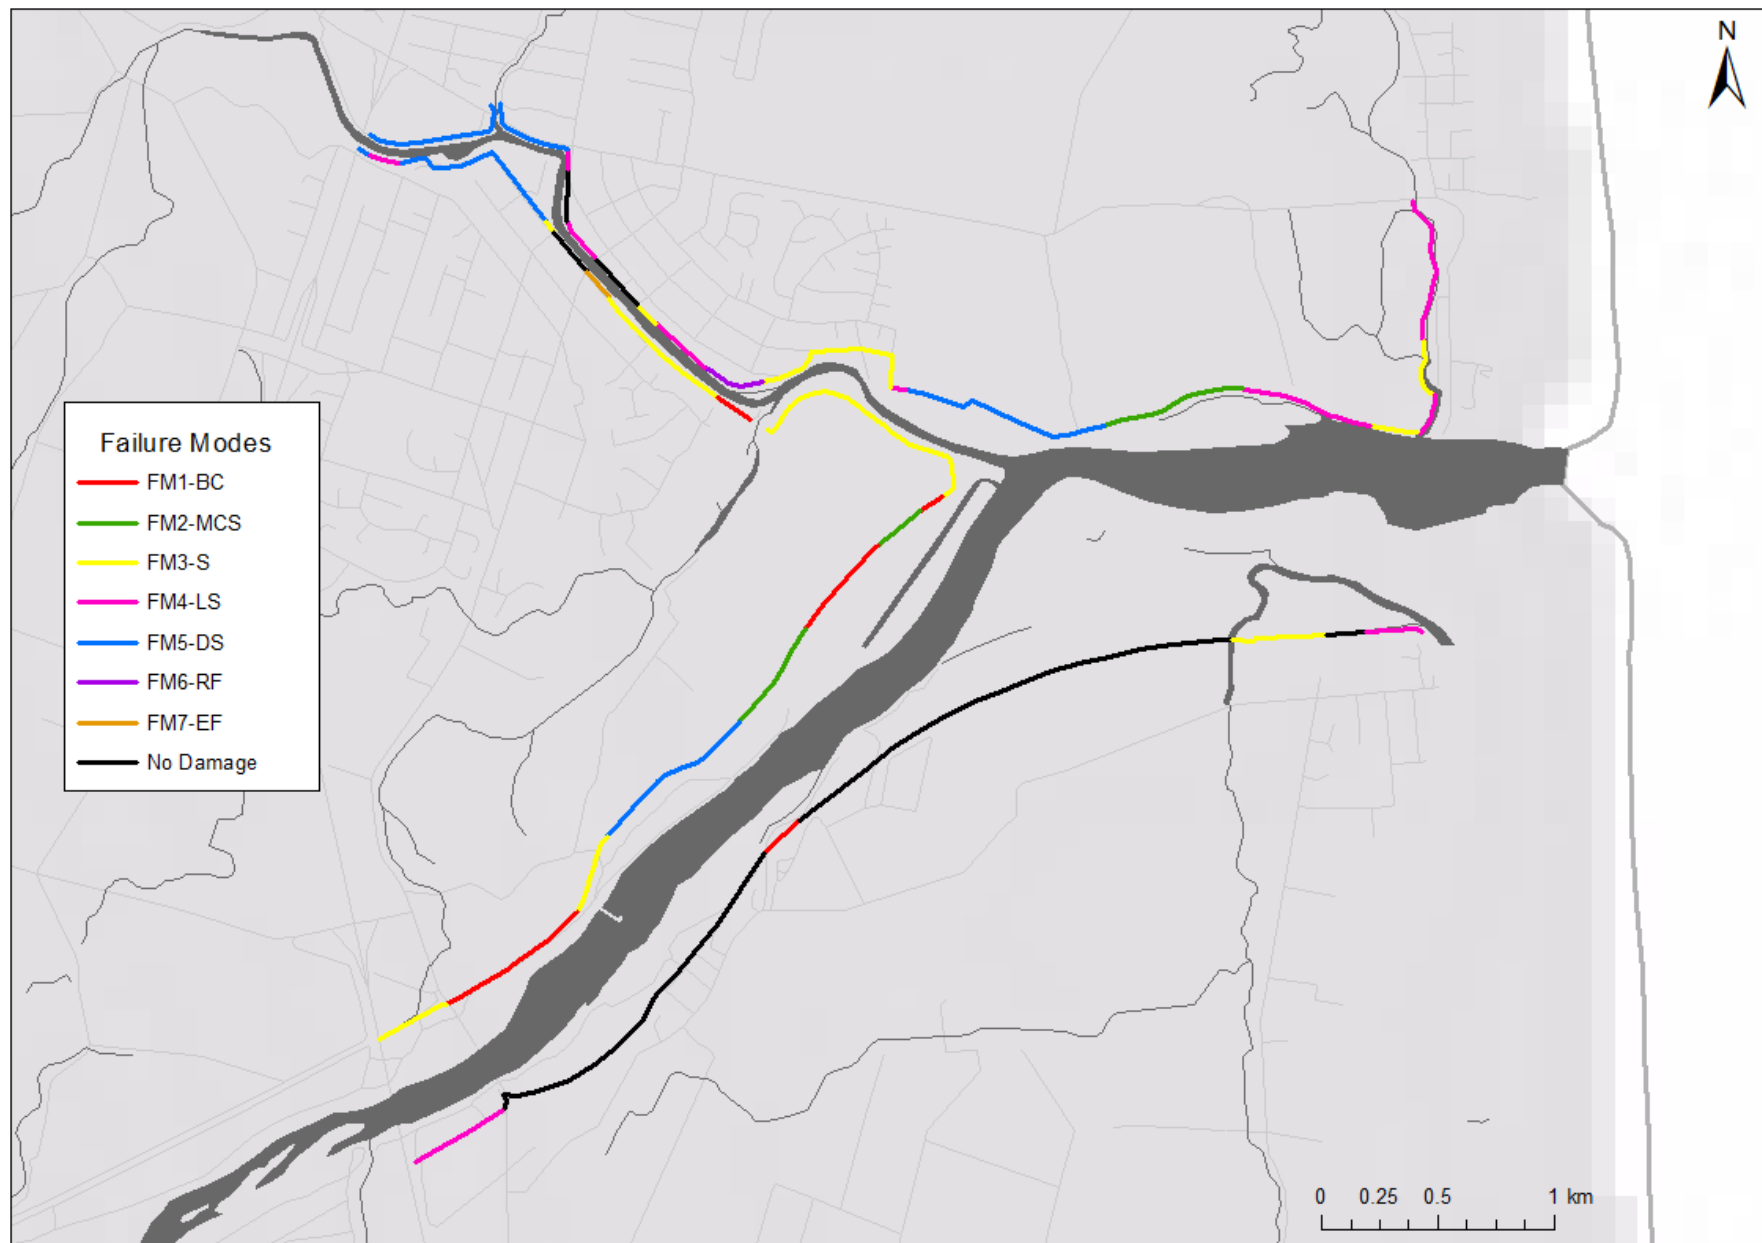
The seven observed stopbank deformation modes are summarised in Table 10 and the extent of these occurrences have been indicated on the maps in Figure 32 for the Waimakariri, Eyre, Cust (WEC) system and Figure 33 for the Avon River system.

FIGURE 32: WEC SYSTEM STOPBANK DEFORMATION MODES

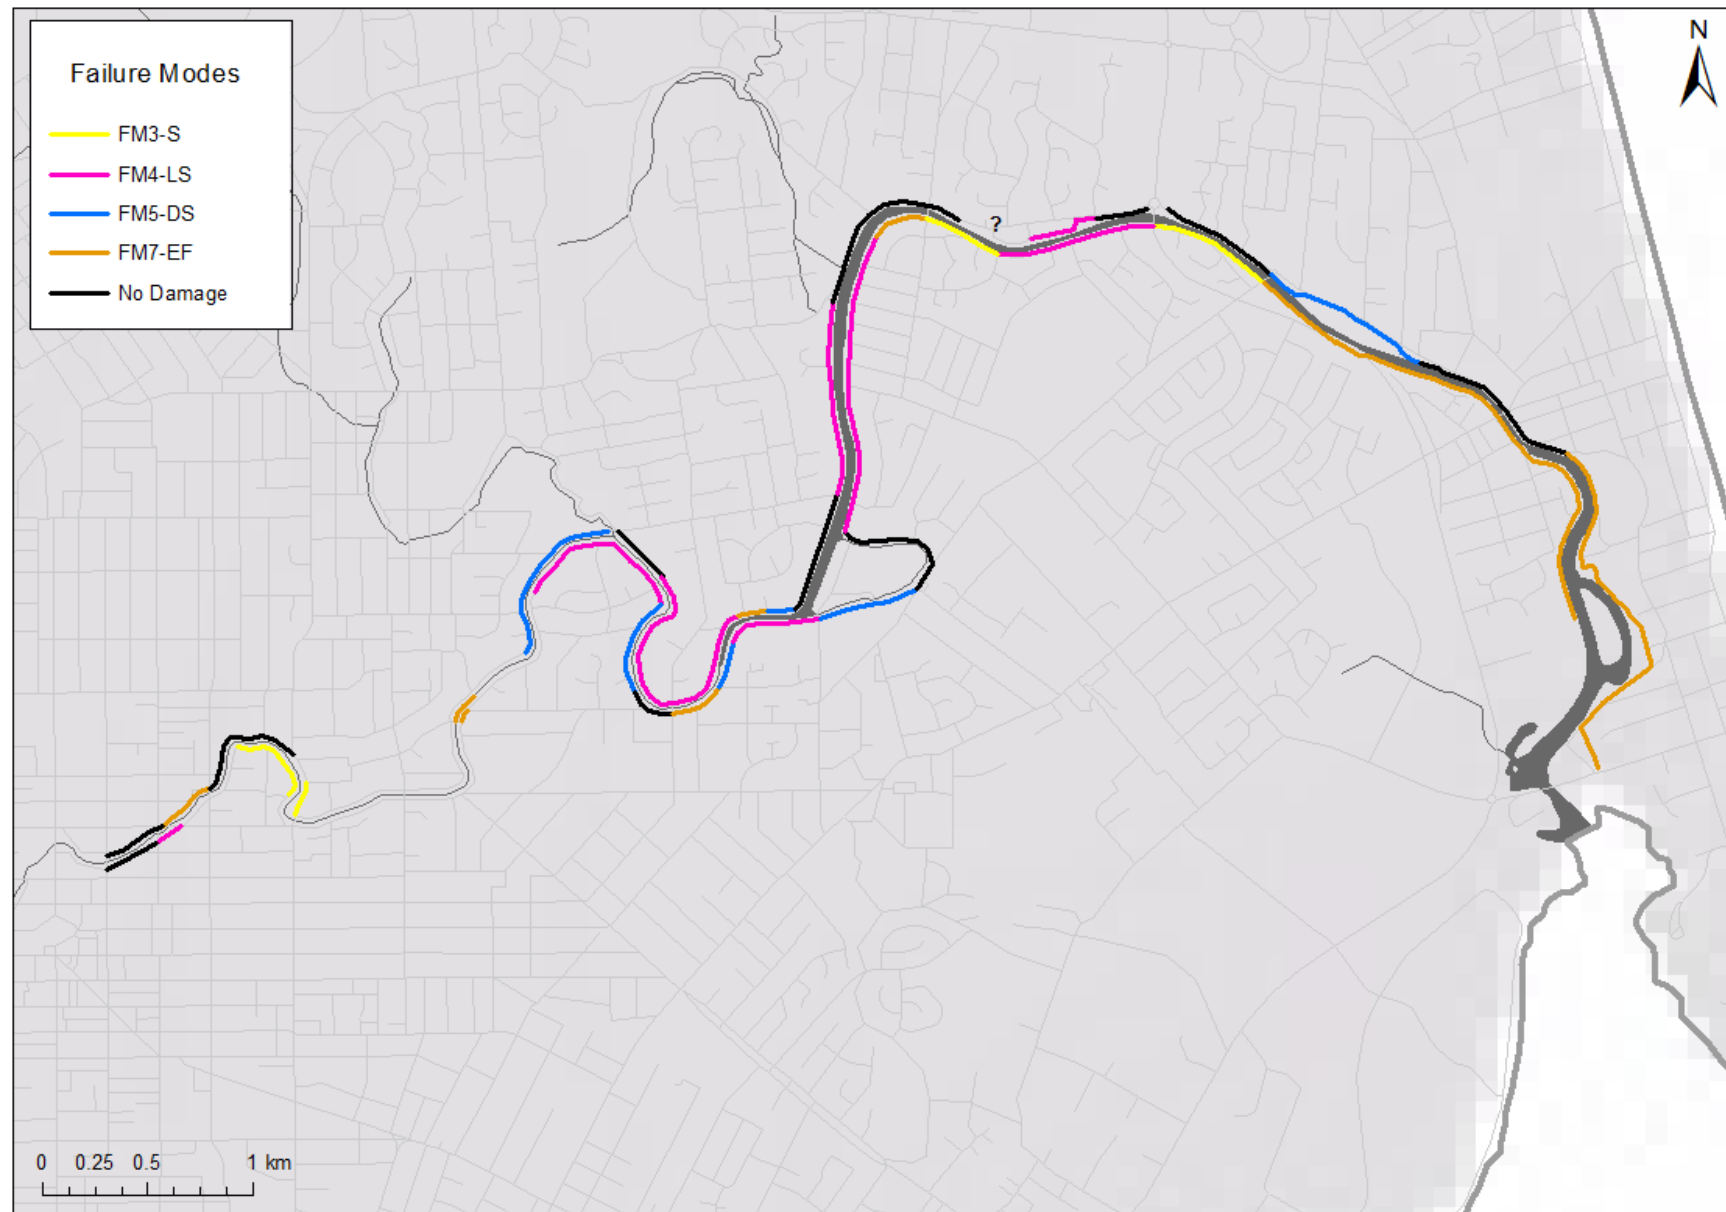
FIGURE 33: AVON RIVER STOPBANK DEFORMATION MODES

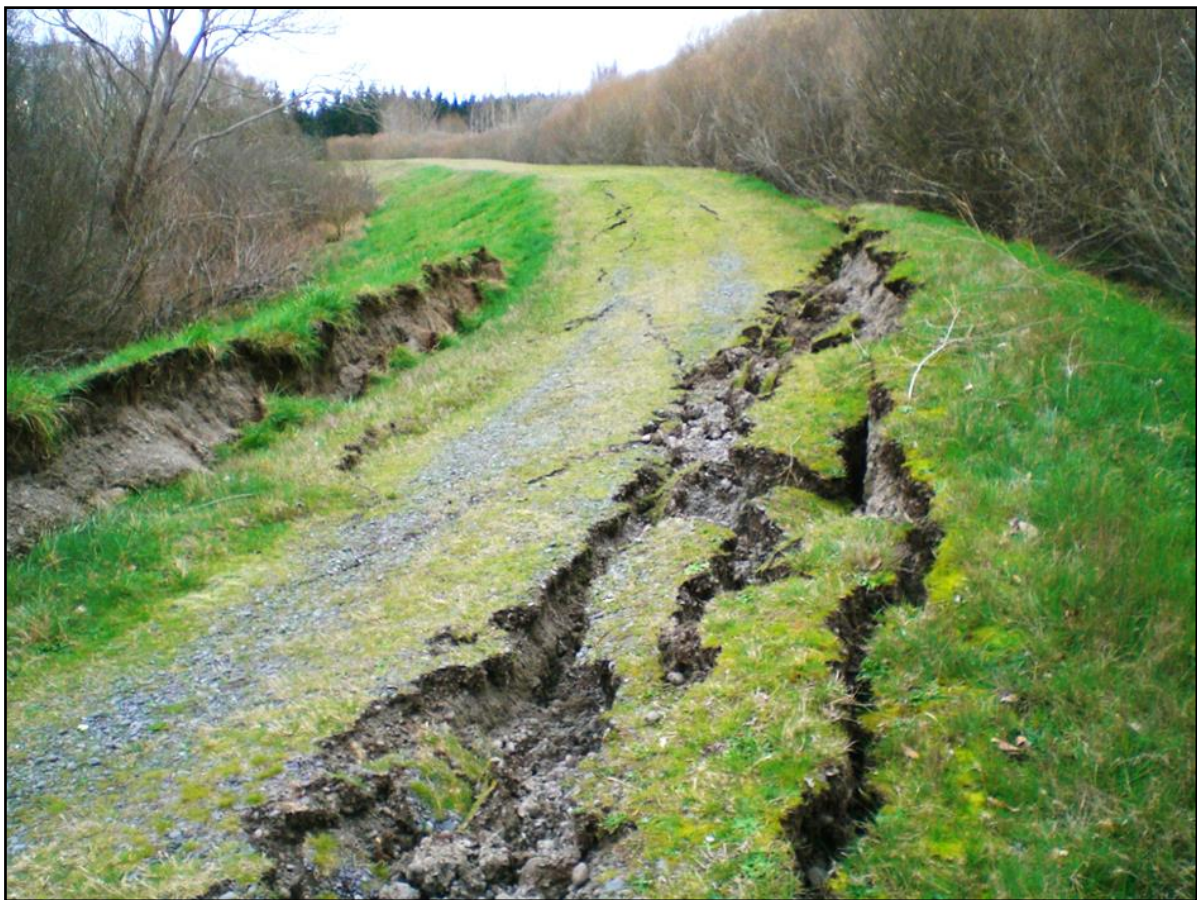
Figure 39 depicts a deformation pattern where slumping of the stopbank has occurred as a result of both settlement and downslope lateral movement. Large cracks and fissures are present due to the loss of bearing capacity due to liquefaction within the foundation soils. An example of this is shown in Figure 40. This deformation mode has occurred along approximately 1.6 km of the WEC system, but did not occur along the Avon River, which is discussed further below.

FIGURE 40: EXAMPLE OF BEARING CAPACITY DEFORMATION (DM1-BC). PHOTO PROVIDED BY ENVIRONMENT CANTERBURY, 2011.
